## Failure Analysis of a Motorcycle Suspension

### ***The Summary***

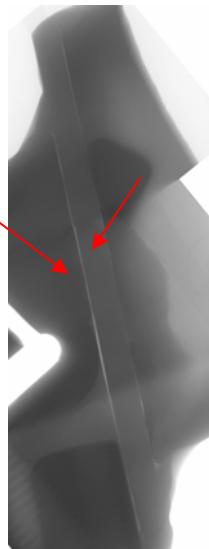
An x-ray microradiograph show how the modifications to the clamp were made. The radiographs show that a large amount of metal was removed and a new piece of metal placed in the cut, to shim the assembly back to the correct width rather than just saw cut and weld together again.

The shim was anchored to the original equipment manufacturer's (OEM) portions of the clamp by welding at the exterior surface. This welding did not penetrate anywhere close to the entire thickness of the part. In the radiograph, long narrow gaps (red arrows) can be clearly seen on both sides of the shim.

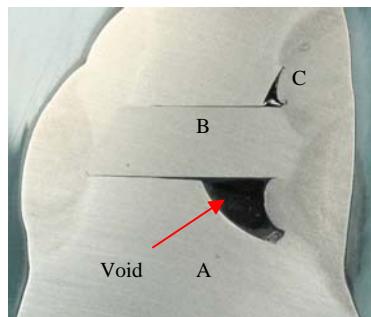
than the original thickness of metal in the clamp, and there is a large void visible in one of the sections.

In the area where the shim was attached, the fused zones of the welds add up to much less

The micrographs also tell us that three different alloys are now present in the modified area. The original alloy in the clamp is very fine grained, with no apparent flow lines, aligned structures, or solidification structures (A). The shim on the other hand is wrought alloy and is different in morphology from the OEM material (B) and the weld can be seen as (C). The data indicates that they used a copper-containing family of aluminum alloys that can be heat treated to improve their strength. In general, these alloys can also be welded successfully.

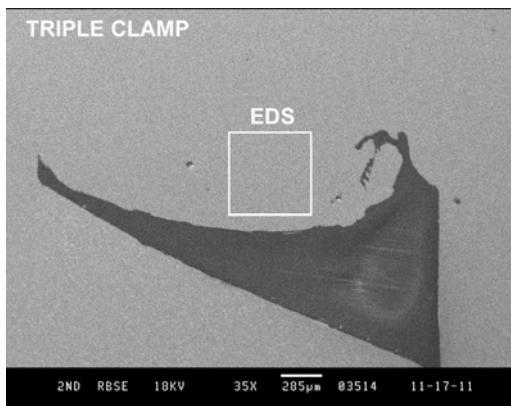
The weld filler is an aluminum-silicon alloy. Silicon lowers the melting point of the aluminum, and helps it flow easily, which reduces porosity in welds and castings. These alloys are also strong and stiff, and commonly used in mechanical applications. The weld filler metal solidified in a cavity or void shown in the micrograph below.

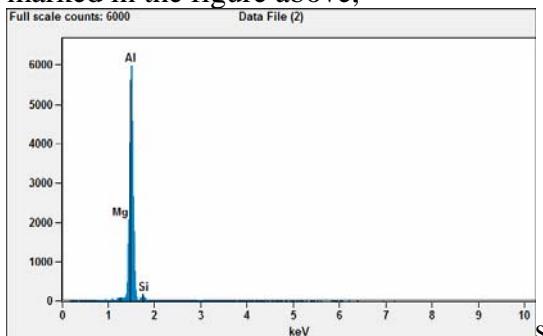
The EDS spectrum, averaged over the area marked in the figure above,

showed aluminum, magnesium and silicon.

The shim is an aluminum-magnesium alloy. These alloys are common in wrought form. They are not especially strong or stiff but are valued more for their wide availability in a variety of useful shapes, and their good malleability and ductility. This material mismatch may have contributed to the failure.
