Failure Analysis of a Motorcycle Suspension

The Summary

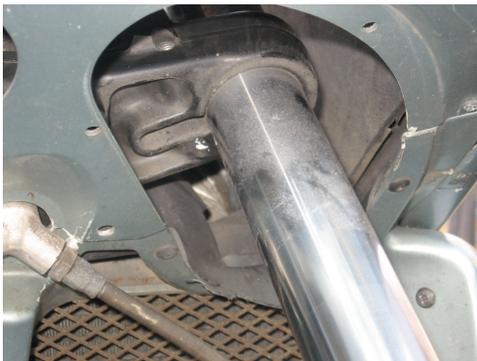
For this particular situation, the lower clamp was modified by cutting and welding. After a while the vehicle acquired a persistent pull to the right. The owner suspected the modified triple clamp.

When the assembly was taken apart they found that the clamp had cracked around the modification of the left fork tube. The damage was so bad that the fork tubes were out of parallel. The damaged part was replaced and a catastrophic failure was averted. But what went on?

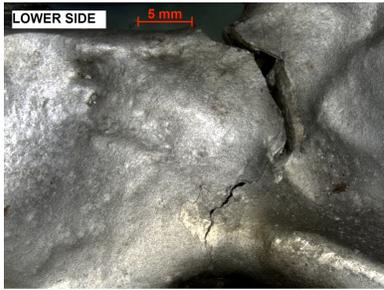
Optical Microscopy

Seeing the problem is a first step and optical microscopy gave a good view of the extent of the cracking.

Surprisingly the cracking was very complex and at least eight surfaces could be observed.

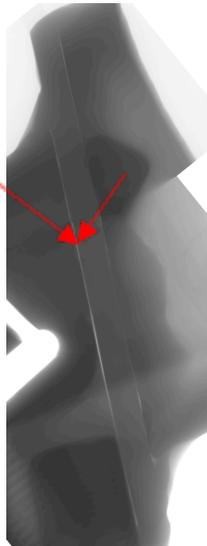
X-Ray Microscopy

An x-ray microradiograph shows how the modifications to the clamp were made. The radiographs show that a large amount of metal was removed and a new piece of metal placed in the cut, to shim the assembly back to the correct width rather than just saw cut and weld together again.

The shim was anchored to the original equipment manufacturer's (OEM) portions of the clamp by welding at the exterior surface. This welding did not penetrate anywhere close to the entire thickness of the part. In the radiograph, long narrow gaps (red arrows) can be clearly seen on both sides of the shim.

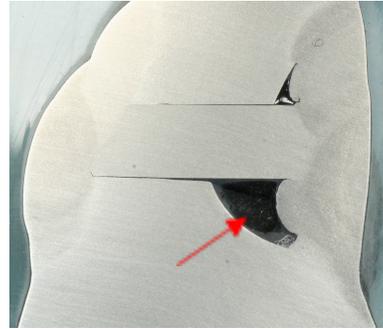
Metallographic Analysis

In the area where the shim was attached, the fused zones of the welds add up to much less than the original thickness of metal in the clamp, and there is a large void visible in one of the sections.

The micrographs also tell us that three

different alloys are now present in the modified area. The original alloy in the clamp is very fine grained, with no apparent flow lines, aligned structures, or solidification structures (A). The shim on the other hand is wrought alloy and is different in morphology from the OEM material (B) and the weld can be seen as (C). The data indicates that they used a copper-containing family of aluminum alloys that can be heat treated to improve their strength. In general, these alloys can also be welded successfully.

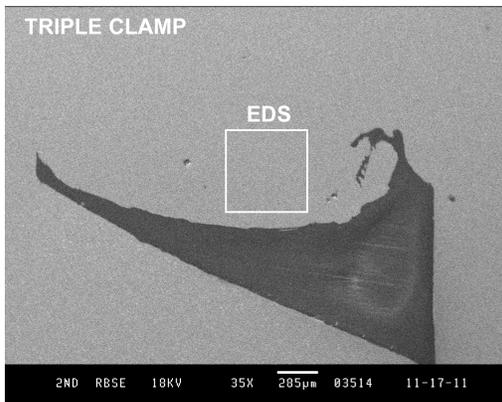
The weld filler is an aluminum-silicon alloy. Silicon lowers the melting point of the aluminum, and helps it flow easily, which reduces porosity in welds and castings. These alloys are also strong and stiff, and commonly used in mechanical applications. The weld filler metal solidified in a cavity or void shown in the micrograph below.

The EDS spectrum, averaged over the area marked in the figure above, showed aluminum, magnesium and silicon.

The shim is an aluminum-magnesium alloy. These alloys are common in wrought form. They are not especially strong or stiff but are valued more for their wide availability in a variety of useful shapes, and their good malleability and ductility. This material mismatch may have contributed to the failure.
