## Failure Analysis of a Motorcycle Suspension

### *The Summary*

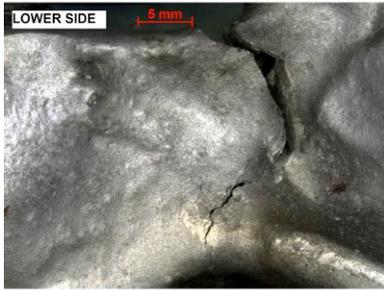
Seeing the problem is a first step and optical microscopy gave a good view of the extent of the cracking.

Surprisingly the cracking was very complex and at least eight surfaces could be observed.

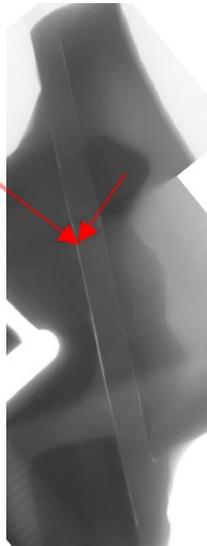
An x-ray microradiograph shows how the modifications to the clamp were made. The radiographs show that a large amount of metal was removed and a new piece of metal placed in the cut, to shim the assembly back to the correct width rather than just saw cut and weld together again.

The shim was anchored to the original equipment manufacturer's (OEM) portions of the clamp by welding at the exterior surface. This welding did not penetrate anywhere close to the entire thickness of the part. In the radiograph, long narrow gaps (red arrows) can be clearly seen on both sides of the shim.

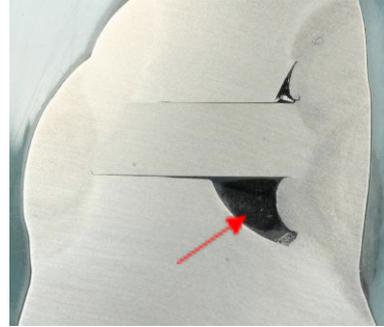
In the area where the shim was attached, the fused zones of the welds add up to much less than the original thickness of metal in the clamp, and there is a large void visible in one of the sections.

The micrographs also tell us that three

different alloys are now present in the modified area. The original alloy in the clamp is very fine grained, with no apparent flow lines, aligned structures, or solidification structures (A). The shim on the other hand is wrought alloy and is different in morphology from the OEM material (B) and the weld can be seen as (C). The data indicates that they used a copper-containing family of aluminum alloys that can be heat treated to improve their strength. In general, these alloys can also be welded successfully.

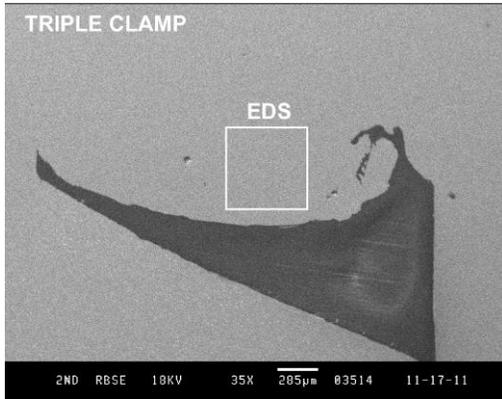
The weld filler is an aluminum-silicon alloy. Silicon lowers the melting point of the aluminum, and helps it flow easily, which reduces porosity in welds and castings. These alloys are also strong and stiff, and commonly used in mechanical applications. The weld filler metal solidified in a cavity or void shown in the micrograph below.

The EDS spectrum, averaged over the area marked in the figure above, showed aluminum, magnesium and silicon.

The shim is an aluminum-magnesium alloy. These alloys are common in wrought form. They are not especially strong or stiff but are valued more for their wide availability in a variety of useful shapes, and their good malleability and ductility. This material mismatch may have contributed to the failure.
