## Failure Analysis of a Motorcycle Suspension

### ***The Summary***

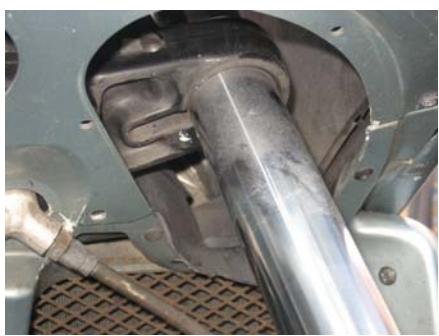
For steering a motorcycle a triple clamp assembly holds the telescoping front fork tubes and headset bearings. These assemblies pivot to steer the motorcycle. In the design, the lower clamp is larger, and carries much of the mechanical load from the front wheel, brakes and suspension, into the bike's frame.
