Failure Analysis of a Motorcycle Suspension

The Summary

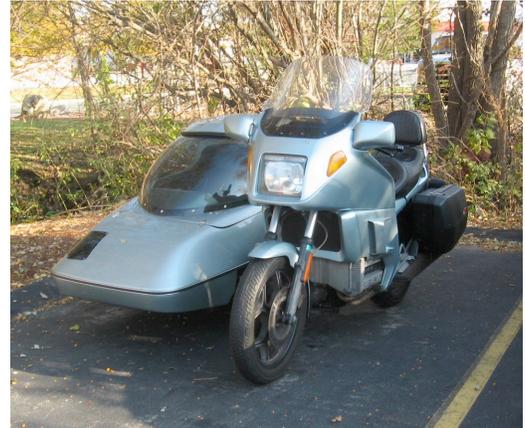
When the assembly was taken apart they found that the clamp had cracked around the modification of the left fork tube. The damage was so bad that the fork tubes were out of parallel. The damaged part was replaced and a catastrophic failure was averted. But what went on?

The fracture initiated and propagated by fatigue. As the load carrying area became increasingly reduced, the failure continued to propagate by overload through the weld.
