## Failure Analysis of a Motorcycle Suspension

### *The Summary*

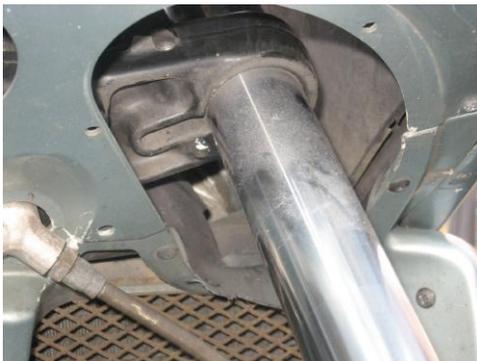
For steering a motorcycle a triple clamp assembly holds the telescoping front fork tubes and headset bearings. These assemblies pivot to steer the motorcycle. In the design, the lower clamp is larger, and carries much of the mechanical load from the front wheel, brakes and suspension, into the bike's frame.

For this particular situation, the lower clamp was modified by cutting and welding. After a while the vehicle acquired a persistent pull to the right. The owner suspected the modified triple clamp.

When the assembly was taken apart they found that the clamp had cracked around the modification of the left fork tube. The damage was so bad that the fork tubes were out of parallel. The damaged part was replaced and a catastrophic failure was averted. But what went on?
